Building Condition Assessment

Corbeil Park Hall

Corbeil, Ontario

LEA Project No.: 22034

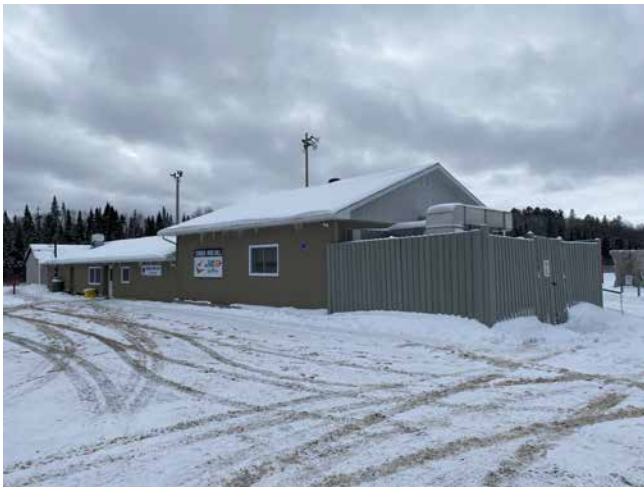
P008 - Northeast Corner

- .5 The fenced enclosure around the exterior pad-mounted HVAC unit at the north end of the building has heaved, likely as a result of concrete post foundations that were not installed below the frost line or provided with frost-protection installation. Further heaving could hinder winter and spring operation of the large gate providing access to the enclosure.

1.4	Fenced Enclosure at HVAC Unit	Abutting north end of the building	Existing wood fencing panels and gate c/w new concrete pier foundations.	P008, P009, P010, P028	5 years	\$15,000	Remove and salvage existing fence panels and gate construction and replace existng concrete foundations with new concrete piers to below the frost line or provide insulation protection as required. Re-stain fence panels and gate.

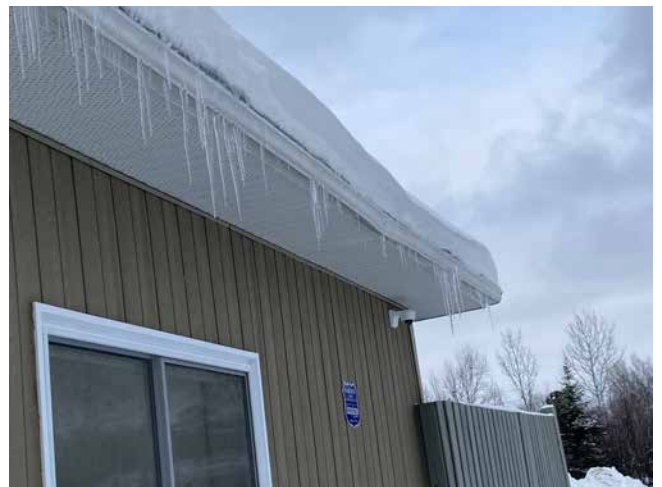
P011

- .5 Building windows are a combination of fixed, horizontal slider and single-hung vinyl units with double-glazed insulating glass units. Windows appeared in good condition though a few screens were observed to have small holes.

2.6	Window Screens	All window units	New fiberglass mesh insect screens in existing vinyl window openings.	P017, P085	IMMEDIATE	\$500	Rescreen all damaged window screens.

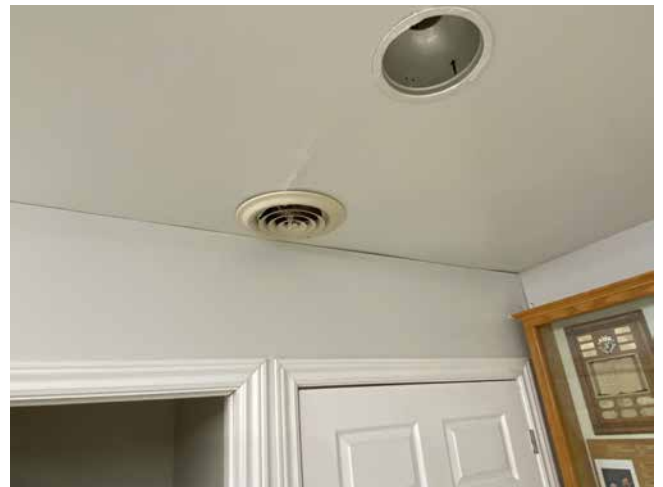
P031 - Hall 100

- .2 As noted by one of the representatives from Township of East Ferris, an ongoing, periodic roof leak (in the Hall) is understood to have been experienced for quite some time, with the water ingress source believed to relate to one of the existing roof-mounted mechanical units. Based on observations from the ground, best-practice roofing techniques to direct water away from roof-top mechanical equipment (such as crickets and flashings) has not been incorporated into the roofing work and there are penetrations through the roof that do not appear to be properly flashed or sealed.

2.2	Roof System Leaks	At roof-top mechanical units and penetrations through the roof	Asphalt shingles, new metal flashings and exterior-grade sealant materials.	P031, P092, P093, P100	IMMEDIATE	\$5,000	Identify and patch current roof leak. Introduce crickets and flashings at roof-top mechanical units to direct water away from the units. Seal all penetrations through the roof. Patch and paint drywalled ceiling in Hall.

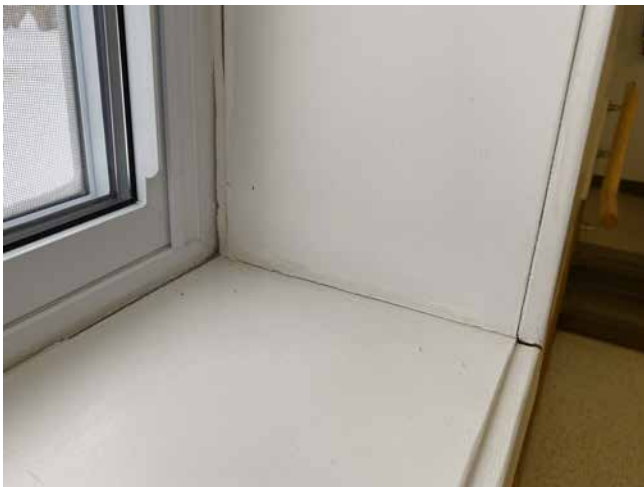
P038 - Hall 100

- .7 Interior sealant work was typically observed to either be absent, or require sealant renewal work at all plumbing fixtures, millwork countertops, around interior perimeter of windows and at all interior trim work.

3.8	Interior Sealant Renewal	Entire building	Sealant renewal at existing plumbing fixtures, millwork countertops, interior perimeter of windows and doors and interior trim work.	P038, P039, P042, P046, P047, P067	IMMEDIATE	\$2,500	Interior sealant installation and/or renewal at all plumbing fixtures and millwork countertops as required to maintain watertightness and around interior perimeter of windows and doors to minimize air infiltration.

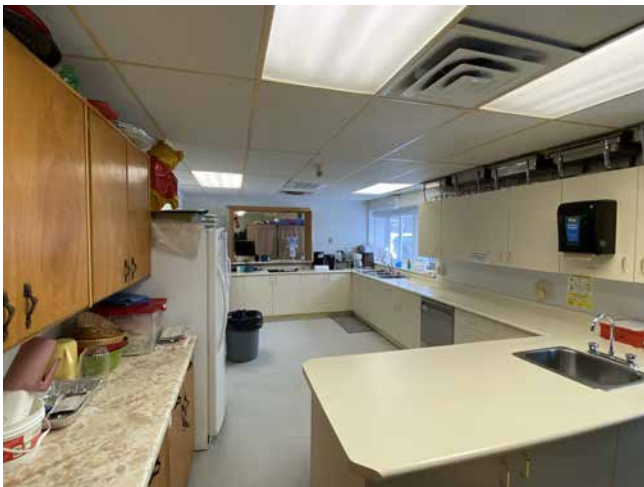
P054 - Kitchen 106

- .5 Door hardware consisted of a mix of commercial and residential-grade components.
 - .6 Extensive millwork in the Kitchen and Bar, including residential-grade melamine and plywood cabinetry and plastic laminate countertops, has all appeared to have reached its useful life.
Vanity millwork and hard-surface countertops in the Men's and Women's Washrooms were observed to be in good condition.

3.10	Millwork Replacement	Bar 102 and Kitchen 106	New millwork and countertops	P043, P054, P055	5 years	\$60,000	Replace all existing
3.11	Rubber Floor Tiles	Hallway 107 and Skate Change Room 110	New vapour-permeable flooring material.	P082, P083, P084	5 years	\$8,500	Remove existing rubber floor tile finish in Hallway 107, Men's WC 108, Women's WC 109 and Skate Change Room 110. Examine underlying concrete floor slab for any signs of mould and / or damage. Note: no costs have been included for any mould remediation or repairs to the concrete floor slab. Install new vapour-permeable flooring in rooms as noted.

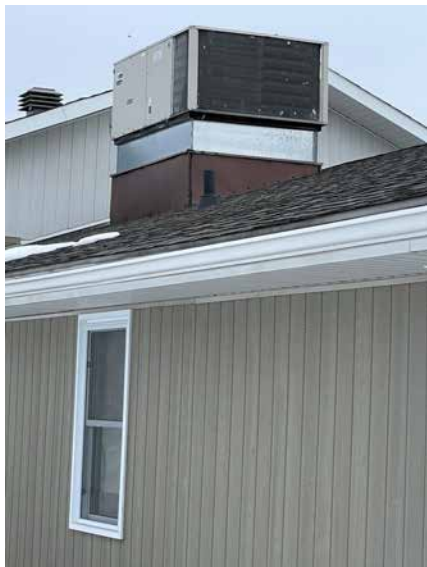
- .2 Based on LEA's site reviews, the Client should be aware of the following building exterior concerns:
 - .1 A number of small exterior openings were observed around the perimeter of the building. These openings, in cladding and soffit materials and at door openings, provide opportunity for small rodents, birds, bats and insects, to enter into the building and cause damage or create unhealthy environments. In particular, the Electrical Room was heavily littered with mouse droppings, both on the concrete floor slab and in the attic space as evidenced by droppings visually observed on the top-side of the plastic roof system vapour barrier.

2.5	Sealing at Exterior Façade	Exterior of building	Existing hardboard siding, vented aluminum soffit and metal door and frame systems.	P014, P015, P021, P023, P026, P099	IMMEDIATE	\$13,000	Replace broken hardboard siding and seal any holes or openings in the cladding. Adjust fit of vented aluminum soffit panels and secure as required. Provide new weatherstripping, door sweeps and thresholds at exterior door and frame systems. Complete exterior joint sealant renewal work at all door and window openings and any other material interfaces.
