Subject: Structural Engineering Report – Arena Roof

EAST FERRIS COMMUNITY CENTRE

STRUCTURAL ASSESSMENT REPORT

PROJECT NO: 19-104

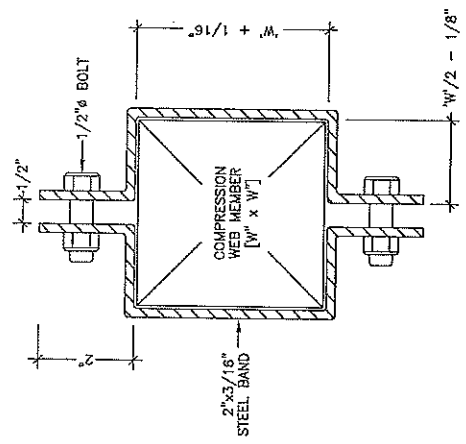
{BAND SPACING @ 30" oc & 90° ALTERNATE ORIENTATION}
BAND DETAIL

Multiple web members showed signs of medium to severe checking and splitting, on multiple trusses. In some instances, previously banded compression web members showed signs of continued significant checking.

Checked members have a reduced resistance to shear and tension/compression loads and require reinforcement to assist the member to bear its load and reduce the rate of further deterioration. Banding is performed to reinforce compression members, and plating of tension members removes the tension from the wood member and transfers it to the steel plate.

B – This compression web member requires reinforcements with 2" x 3/16" thick Galvanized Steel Bands. Refer to Drawing SK-1 for fabrication details plus spacing and orientation requirements of the bands.

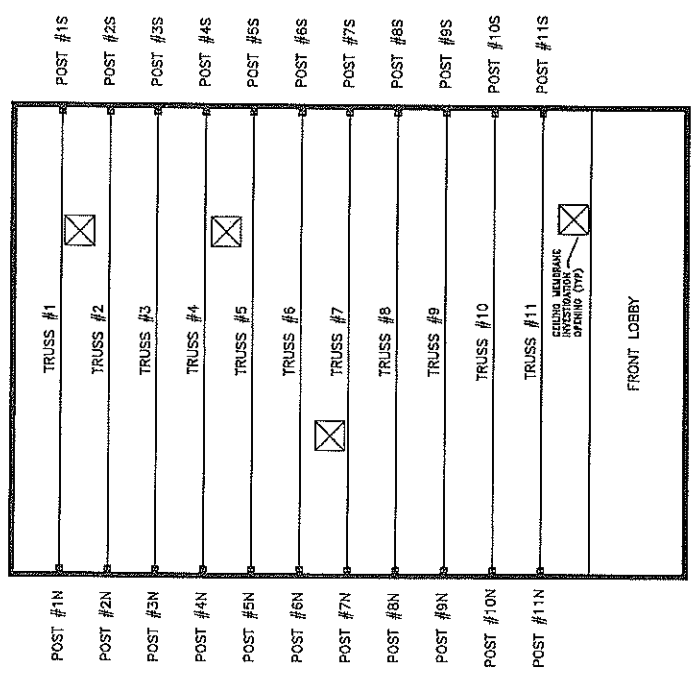
ARENA PLAN

In general, multiple timber posts supporting the truss structure showed signs of checking. The posts near the players benches and penalty box area (#4S, #5S and #6S) showed indications of impact damage and it is suspected that this was due to damage incurred by the players hockey sticks and skates. The location of the posts can be found on Drawing SK-1.

The reflective insulation membrane was opened at four locations (See Drawing SK-1) to allow for visual inspection of the purlins and underside of the roof sheathing. The visual investigation of the roof purlins and roof sheathing revealed no indication of structural deterioration at the examined areas.

With respect to the posts supporting the trusses we did not review any post deterioration or damage that would warrant the posts being changed at this time. A number of posts have been replaced since the 2016 inspection and it is proposed that the balance of the posts be changed with a number of the most severely checked and damaged ones being done each year.

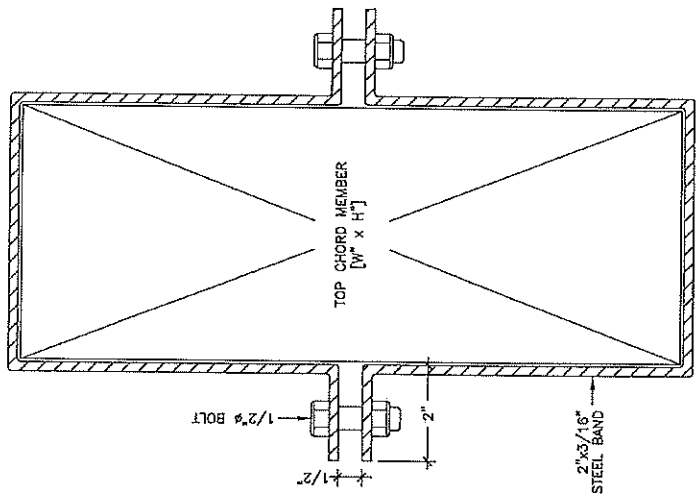
TOP CHORD BAND DETAIL

The top and bottom chords are comprised of multi-ply glue laminated timber sections, laminated along their weak axis'. Delamination of the plies was observed, at several locations, meaning the plies are separating from each other. As a result, the plies may begin to carry loading as individual members, no longer forming a solid member, and therefore reducing the member's strength. Longitudinal checking was also observed at multiple locations on multiple trusses.

The top and bottom chords of the trusses are showing signs of delaminating as well as checking, and require remedial action. Although this was not previously discovered during our other past assessments, it is evident that the delamination has been present for multiple years. A different method of investigation was implemented during this assessment that allowed us to discover this ongoing deterioration.

Full replacement of the roof structure is again recommended. Reinforcement methods for the weakened members may be implemented to further prolong the life of the trusses and provide time for the municipality to develop a replacement and funding strategy. Details pertaining to the reinforcement methods can be found on Drawings SK-1 plus SK-2 and details of the required repairs are outlined in Table 1.
