Building Condition Assessment

Corbeil Park Hall

Corbeil, Ontario

LEA Project No.: 22034

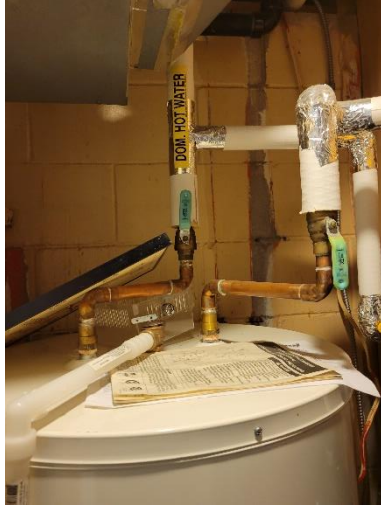
Photo 1

1. Code Requirement:
 1. Provide independent grease interceptor for the dishwasher unless prohibited by local municipal bylaw.
 2. Recommend installing a mixing valve on main domestic hot water heating unit to temper water to 120 deg. F throughout building with exception to the kitchen. Domestic hot water tank water temperature to be set to 140 to limit the growth of legionella bacteria. Refer to Photo 1.

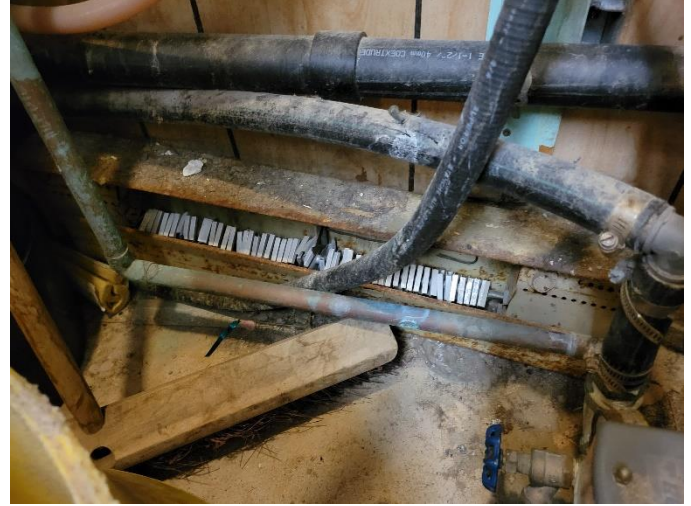
Photo 2

2. Best Practices
 1. Recommend relocating existing electric baseboard heater in custodial closet as incoming water and sanitary lines (plastic) are routed so close that damage is likely should it ever turn on. Refer to Photo 2.

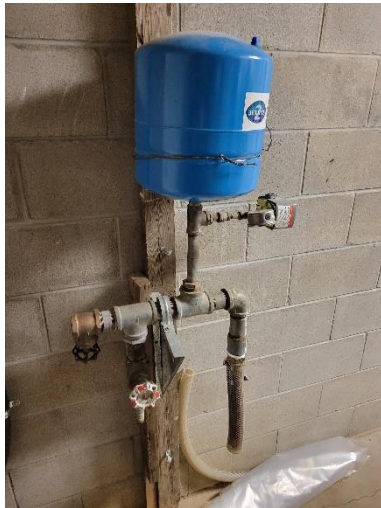
Photo 3

4. It is recommended that all decommissioned equipment, piping, valves, etc. be removed of and disposed off of site. Refer to Photo 3.

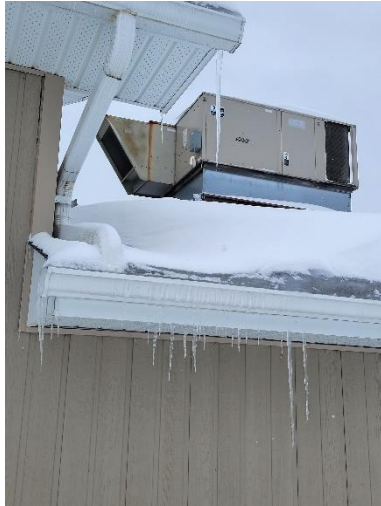
Photo 5

1. Replace roof mounted air handling unit with newer more efficient heat pump model. Existing unit is well passed its median life expectancy and due to the refrigerant used cannot be repaired without considerable costs. Consideration should be given to replacement once repair work becomes burdensome. Refer to Photo 5.

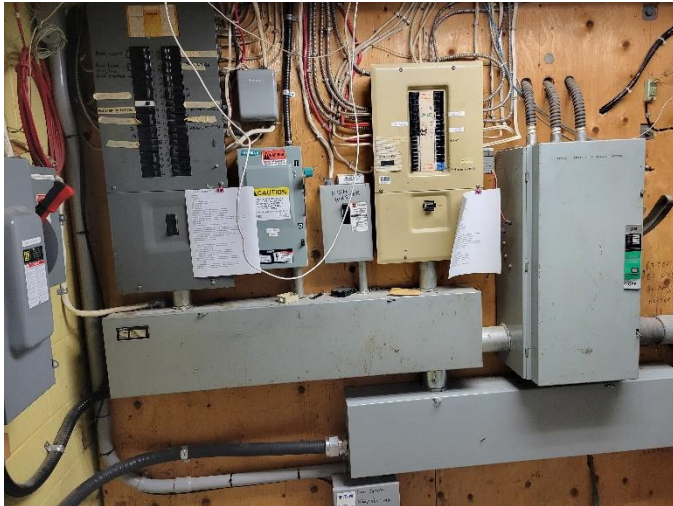
Photo 7

1. Receptacles located throughout building interior.
2. Wiring throughout building a mix of NMD cabling, BX armoured cable, TECK cable and plastic conduit. It is assumed that a majority of the existing building previous to the 2013 renovation is serviced by the NMD cabling from the older panels. Refer to Photo 7.
3. A number of electrical fan forced unit heaters are installed throughout the community hall space totalling approximately 10 kW (as per 2013 renovation drawings). Electric heating panels installed in the washrooms with the skate/change room being served by an electric cabinet unit heater. These items were installed during the 2013 renovation and are all approximately 10 years old. Some older fan forced heaters were noted on site at the main entrance and in the kitchen space, however their age and electrical capacities are unknown.

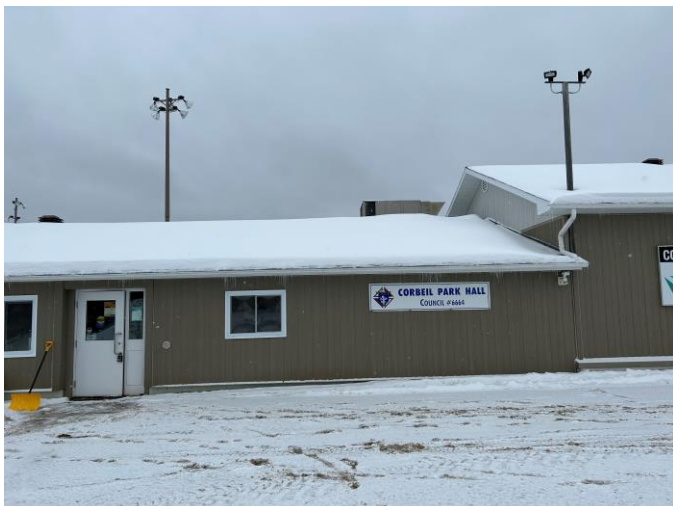
Photo 9

1. Exterior Observations:
 1. It was noted that the existing surrounding grade near the main entrance on Gridline A, near Gridline 2, appeared to slope towards the structure. Refer to Photo 9.

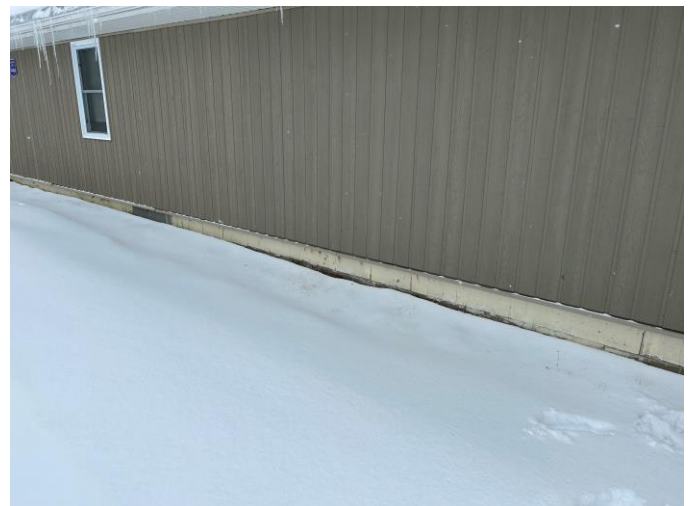
Photo 10

2. Select narrow to medium vertical cracks were noted in select locations of the exposed portions of foundation walls. Refer to Photo 10.
 3. Significant amounts of ice build-up were noted at select locations on the roof, near the eaves. Refer to Photo 11.

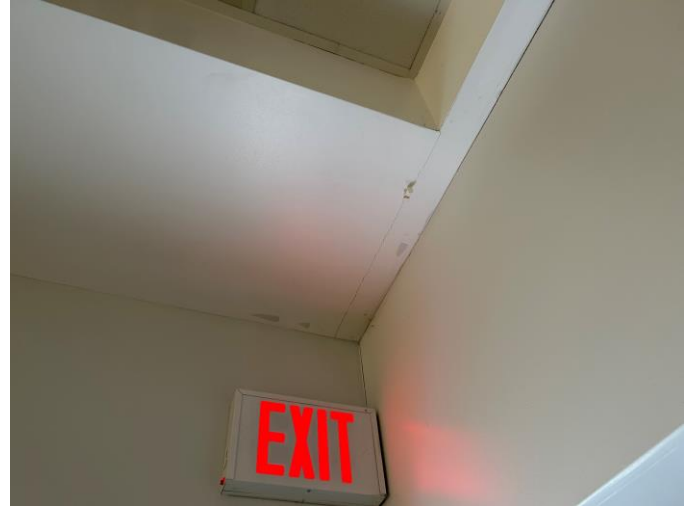
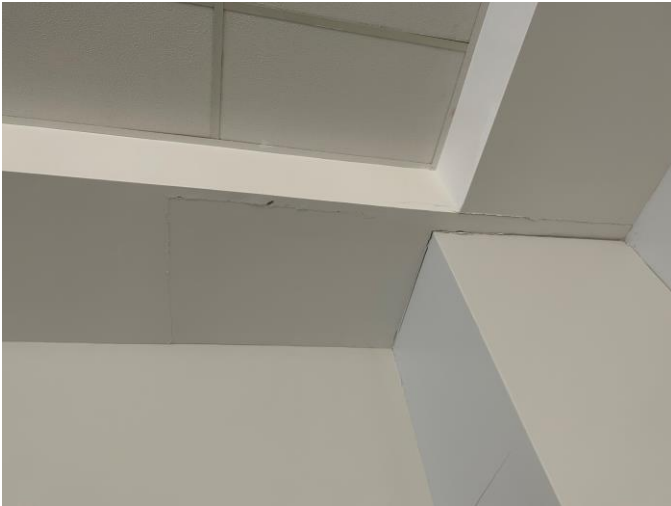
2. Interior Observations:
 1. General medium cracking in gypsum wallboard finishes was observed in several locations between Gridline 1 and 2. Refer to Photos 12 and 13.

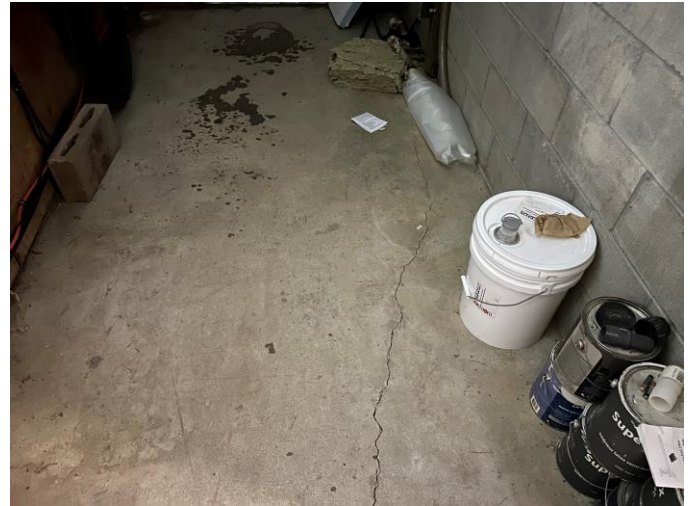
Photo 14

2. Suspected water infiltration was observed along the underside of the ceiling finishes near the display cabinets along Gridline B.
 3. General medium cracking of the slab on grade in the Electrical Room was noted. Refer to Photo 14.
