FINAL CULVERT INSPECTION REPORT – EAST FERRIS

Project No.: EF – 2023-03
Culvert Evaluation/Survey

June 2023

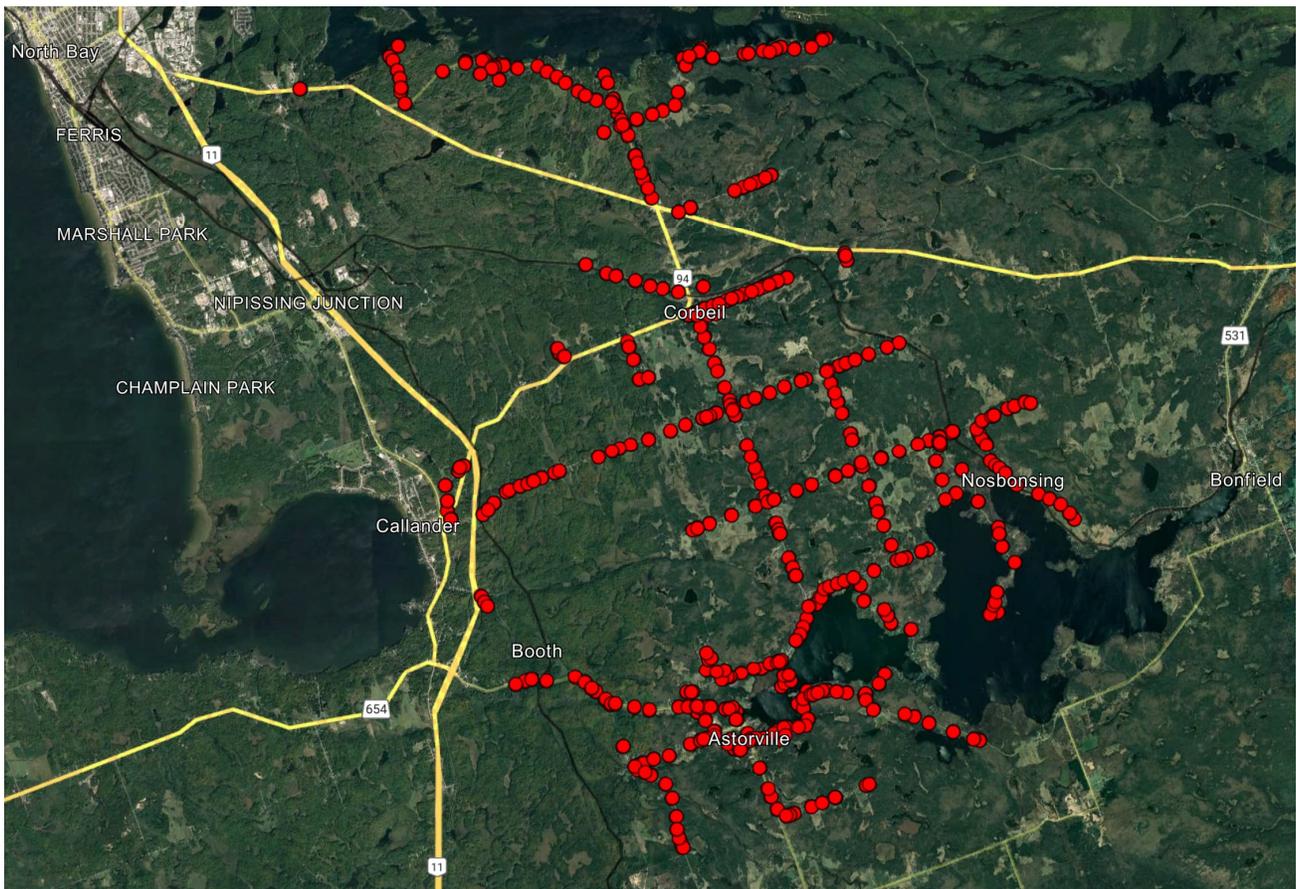
Figure 1 – East Ferris Culvert Evaluation Map

The project limits included 60 roads spanning 110 km. The roads are a mixture of paved, surface treated and gravel with varying amounts of traffic. All culverts inspected were non-structural (spans less than 3 m). A map including culvert points is shown in Figure 1 below.
